## Memorandum

*Subject: Summary of Oversight of Cap Inspection at River Mile 10.9  
March 21-22, 2019  
Lower Passaic River Restoration Project*

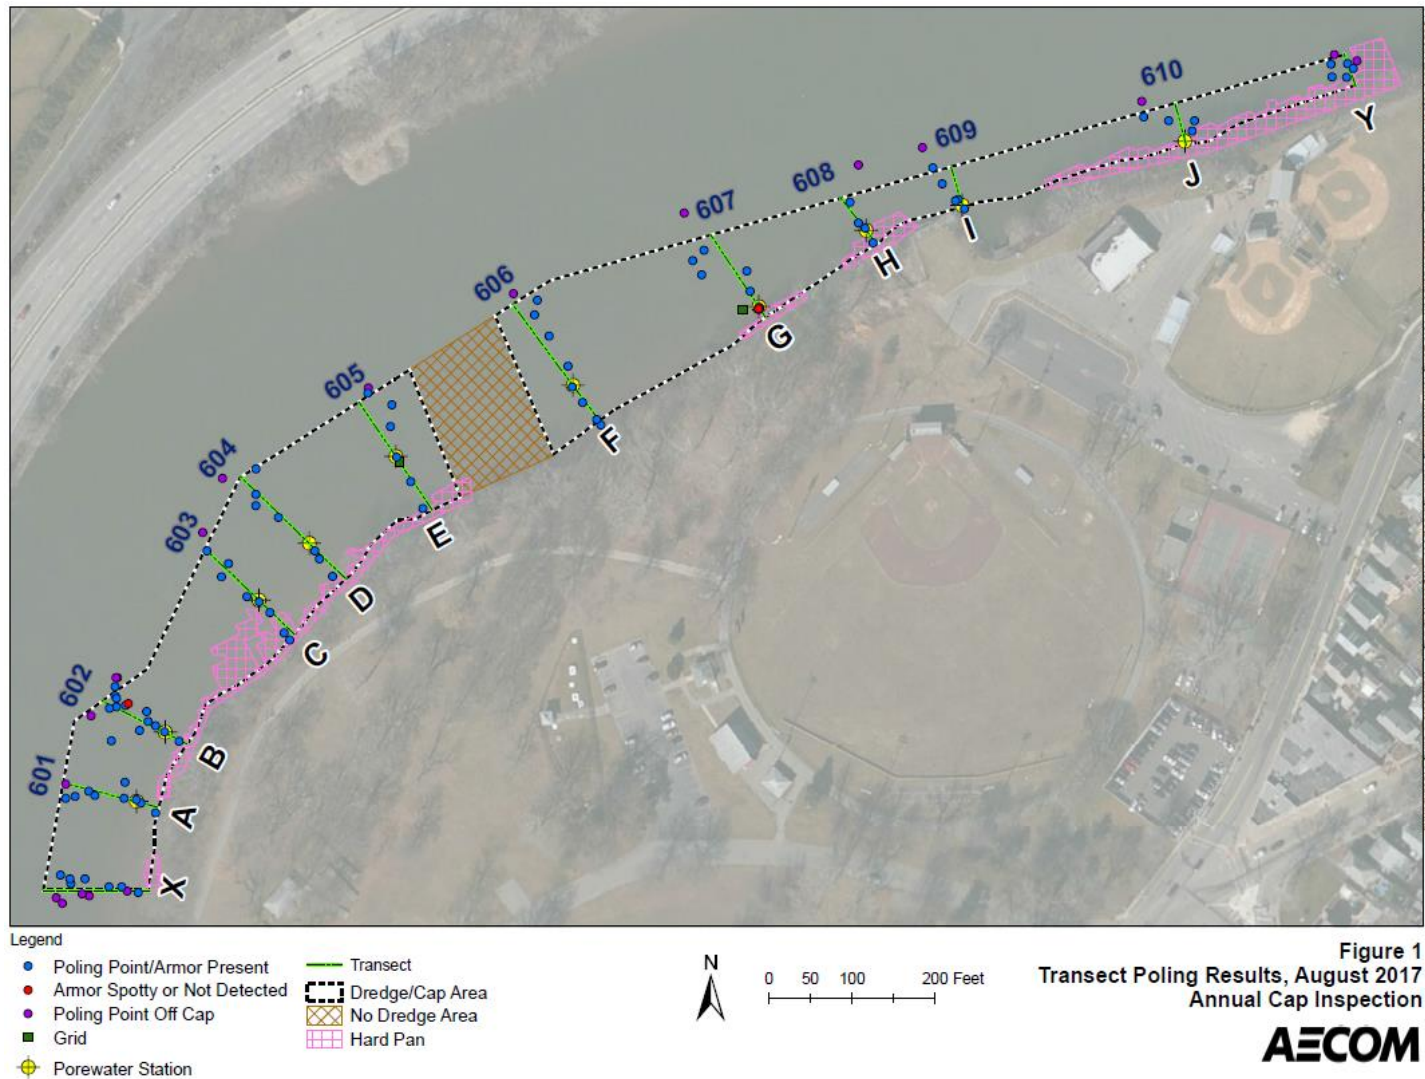
Figure 1

**Figure 1: Figure of poling/probing transects and sampler stations. Poling points displayed are from the August 21-22, 2017 cap inspection event. NOTE: An update to this figure with the poling points from the March 21-22, 2019 cap inspection will be created when the GPS coordinates of the September 2018 cap inspection are received from the CPG.**

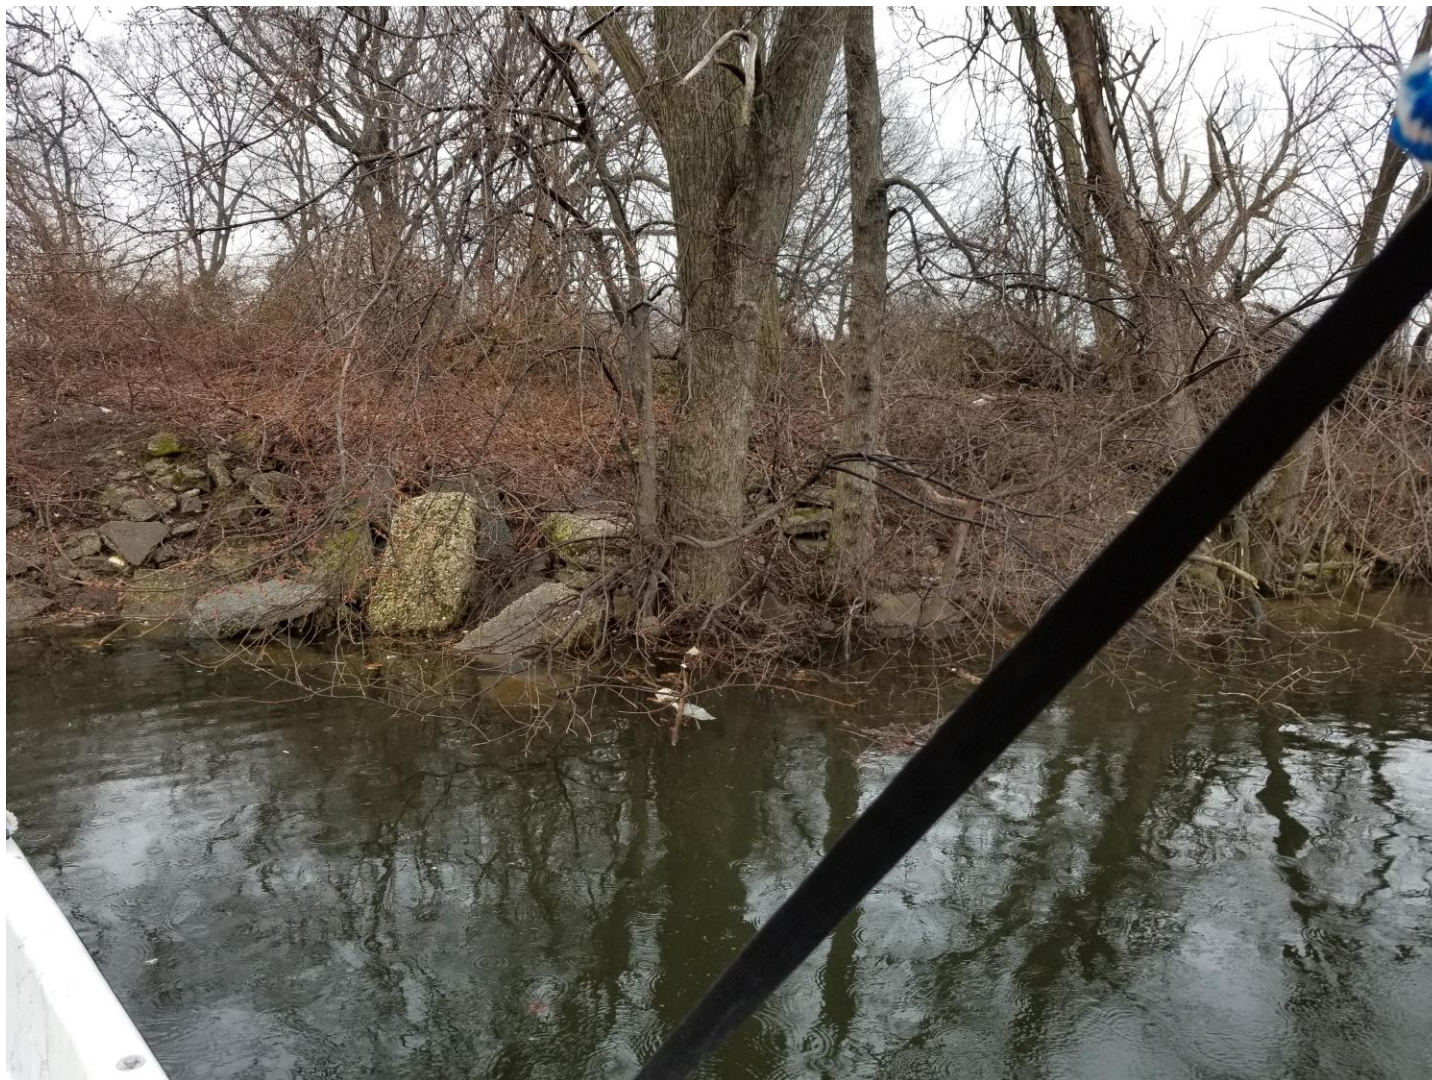
Shoreline at location A-1 (3/21/2019 8:31)

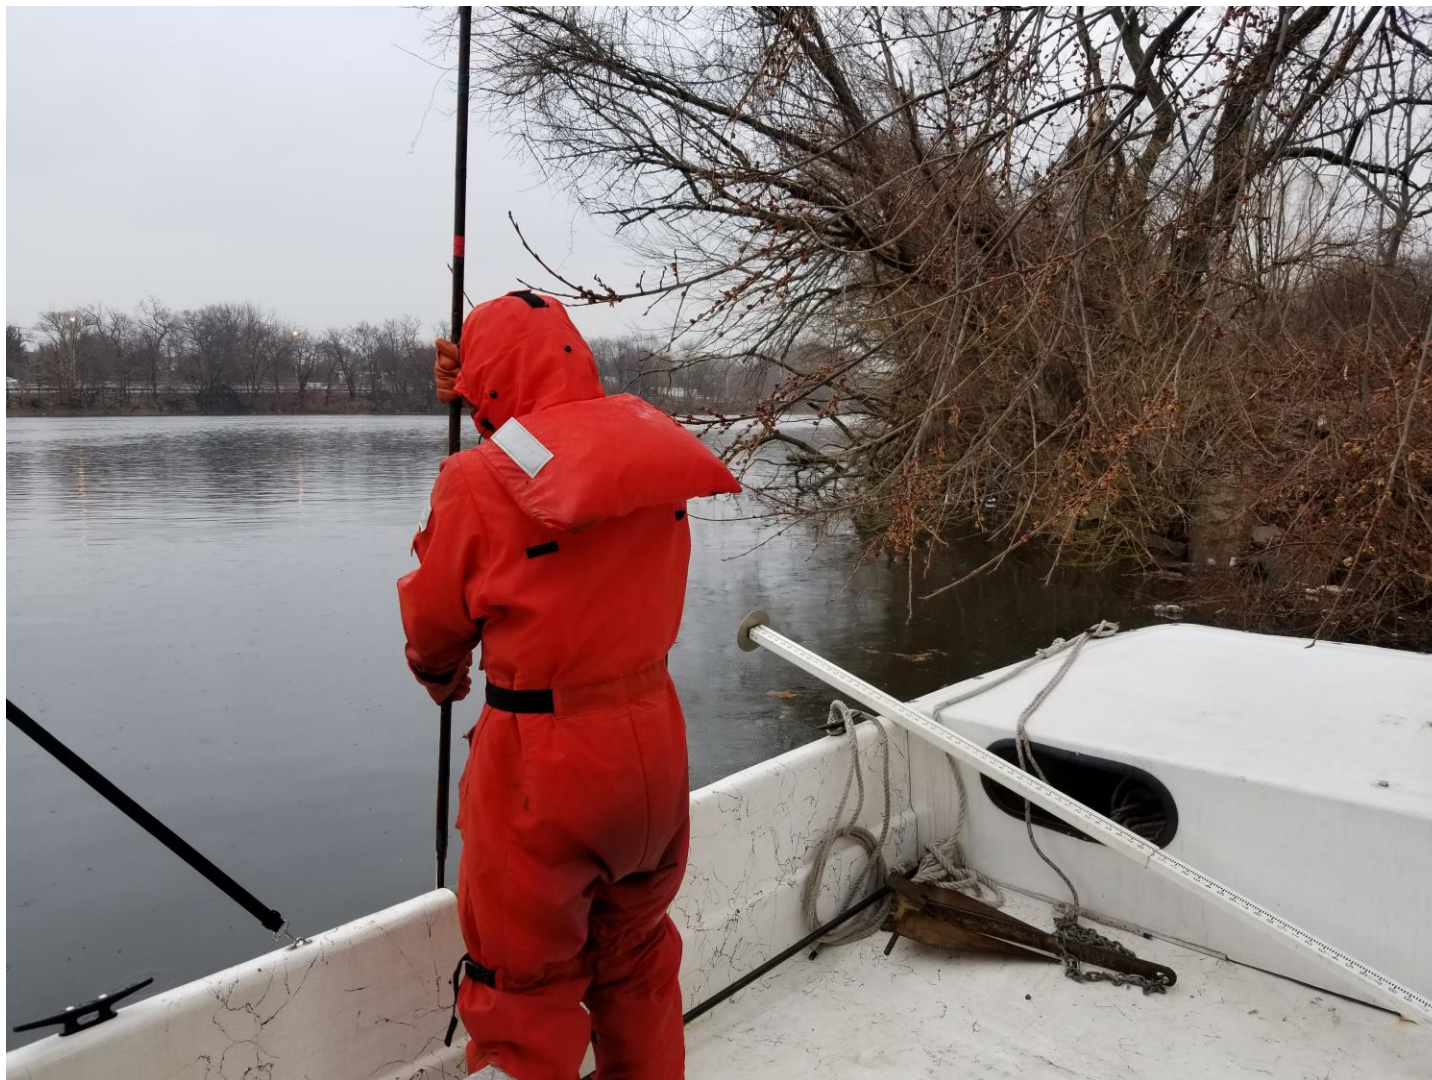
Hugh Lincoln (OSI) poling for armor at location A-1 (3/21/2019 8:31)

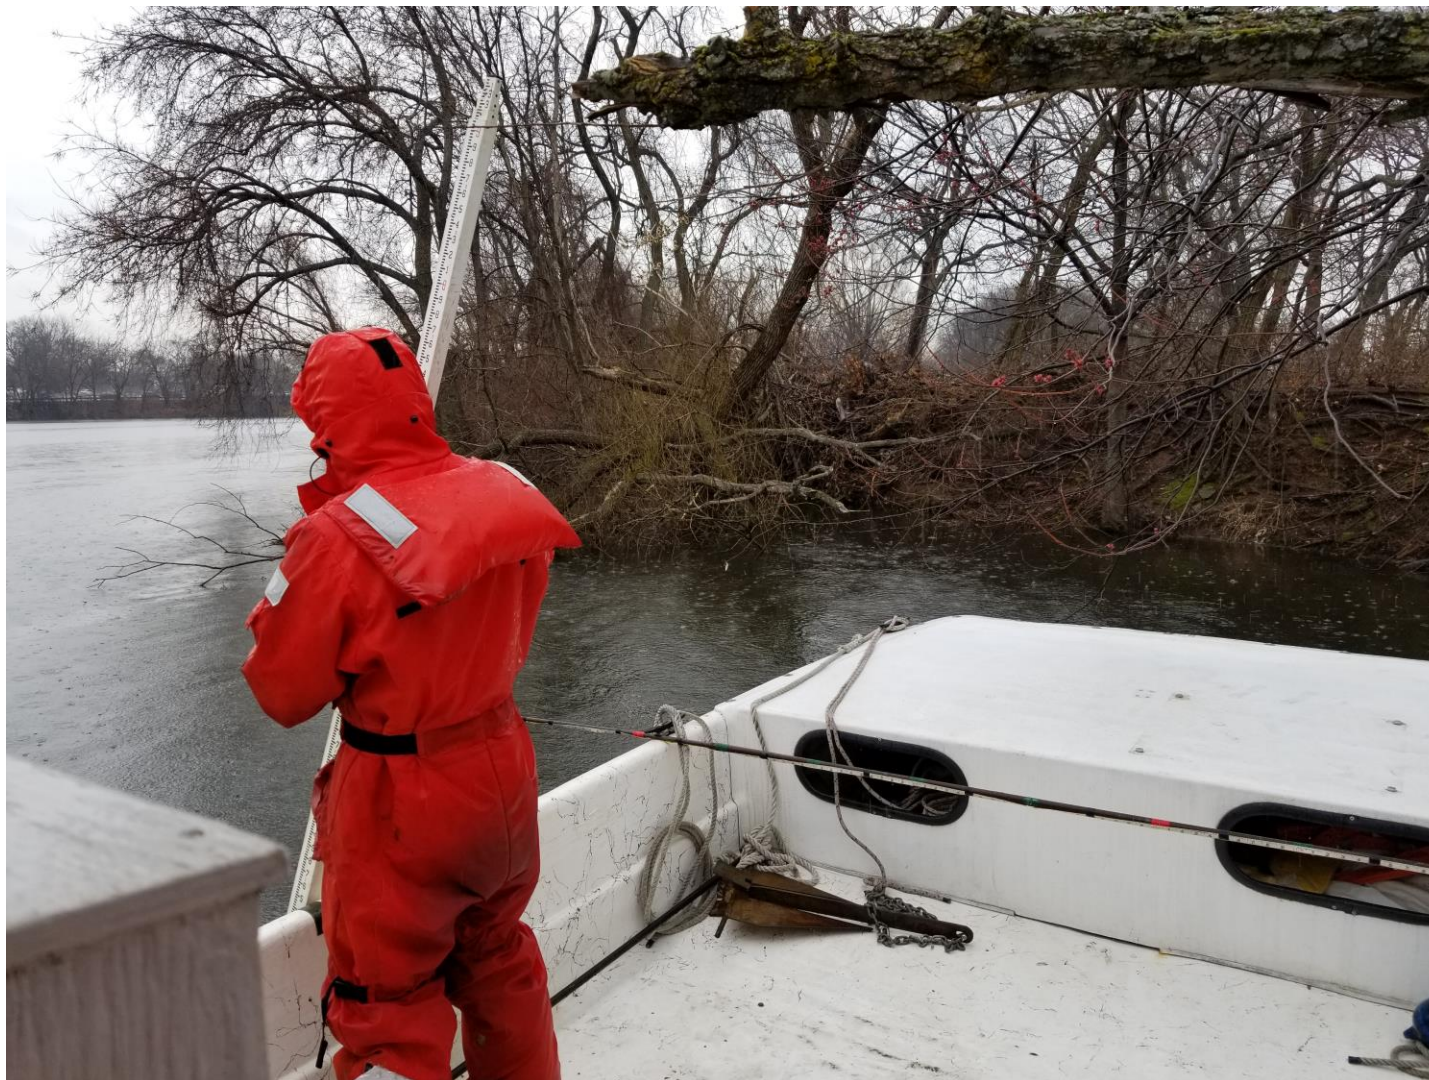
Hugh Lincoln measuring depth to sediment at location X-1a (3/21/2019 8:54)

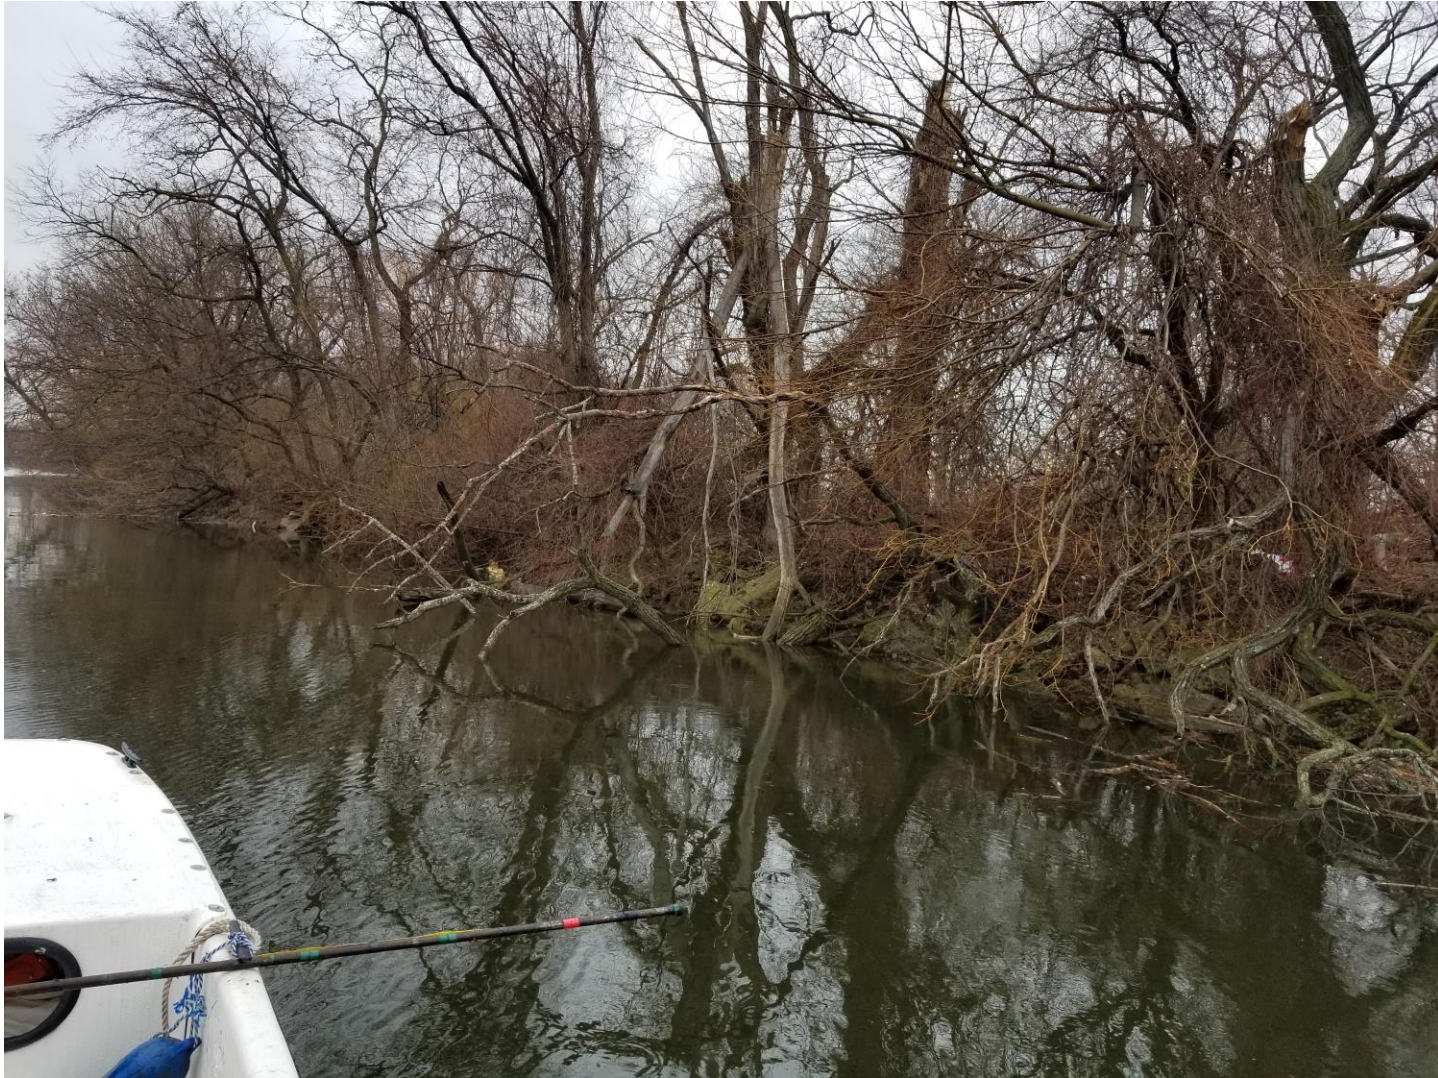
Shoreline at location B-1 looking North (3/21/2019 9:12)

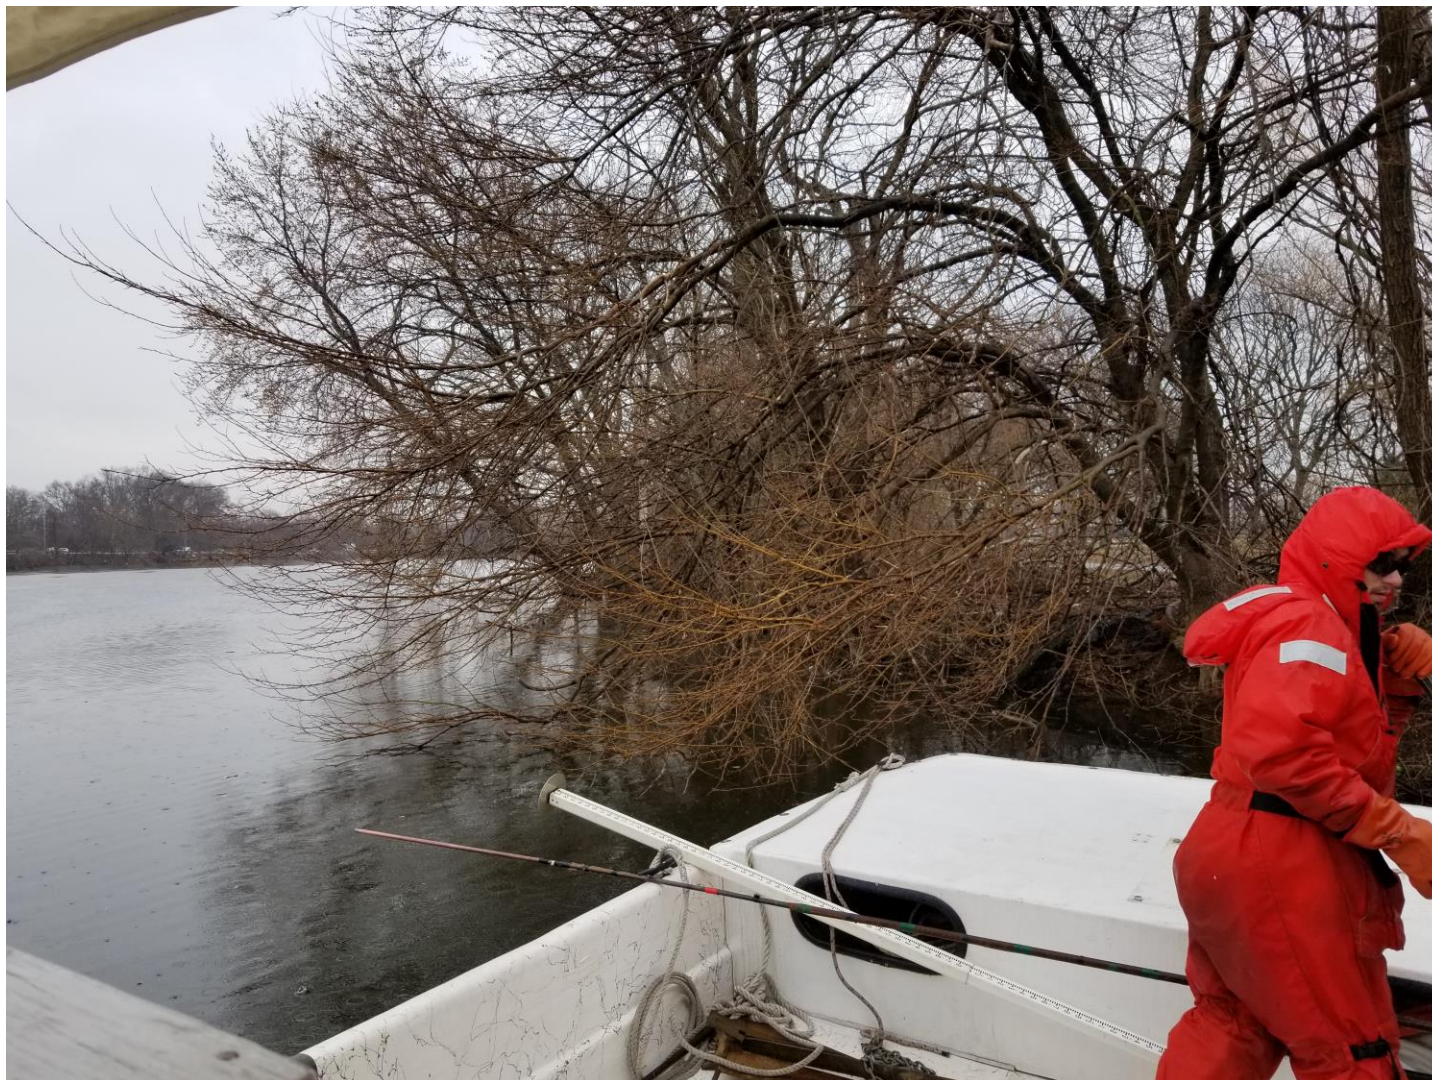
Shoreline at location C-1 looking North (3/21/2019 9:35)

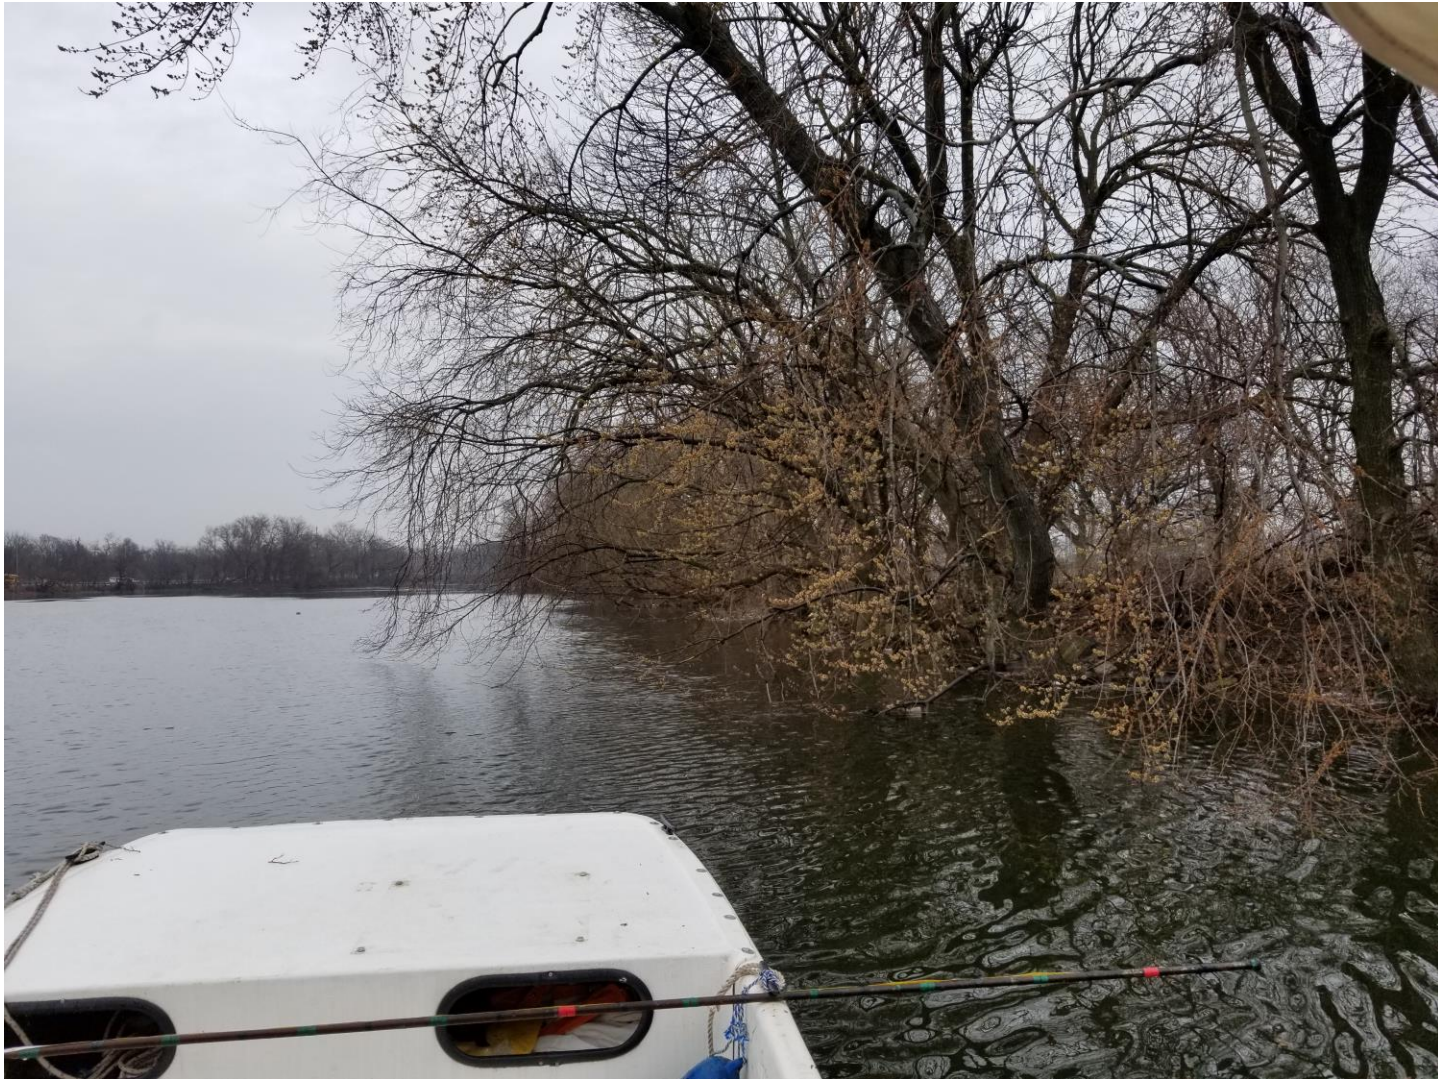
Shoreline at location D-1a looking North (3/21/2019 9:47)

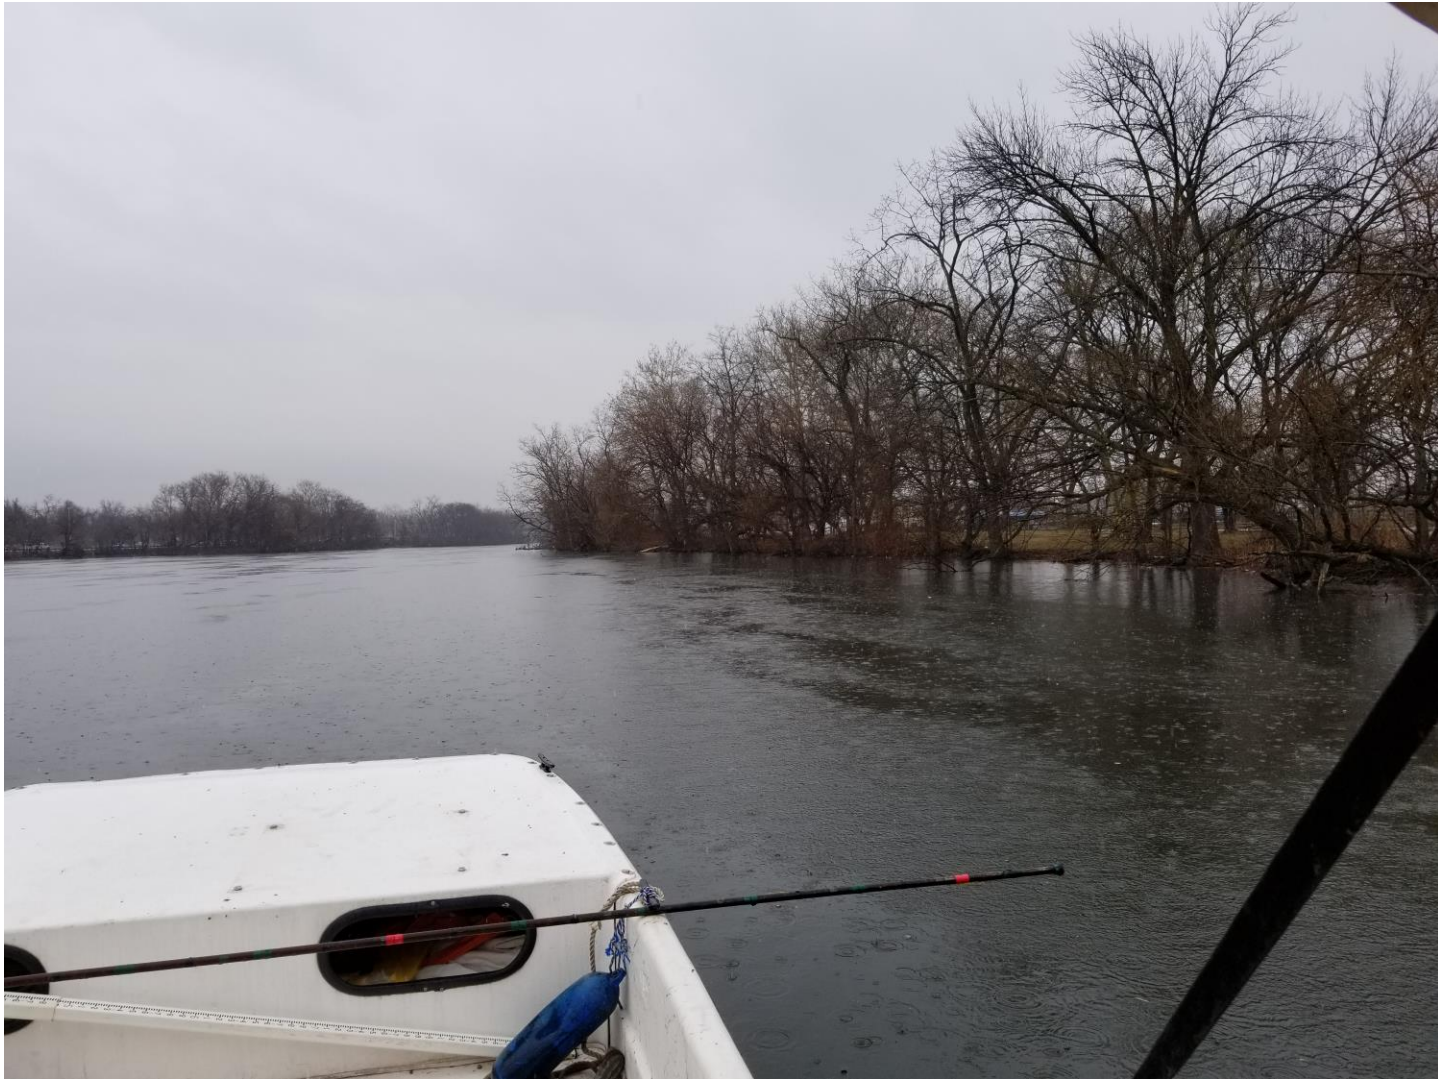
Looking North at location E-4 during heavy rains (3/21/2019 10:26)

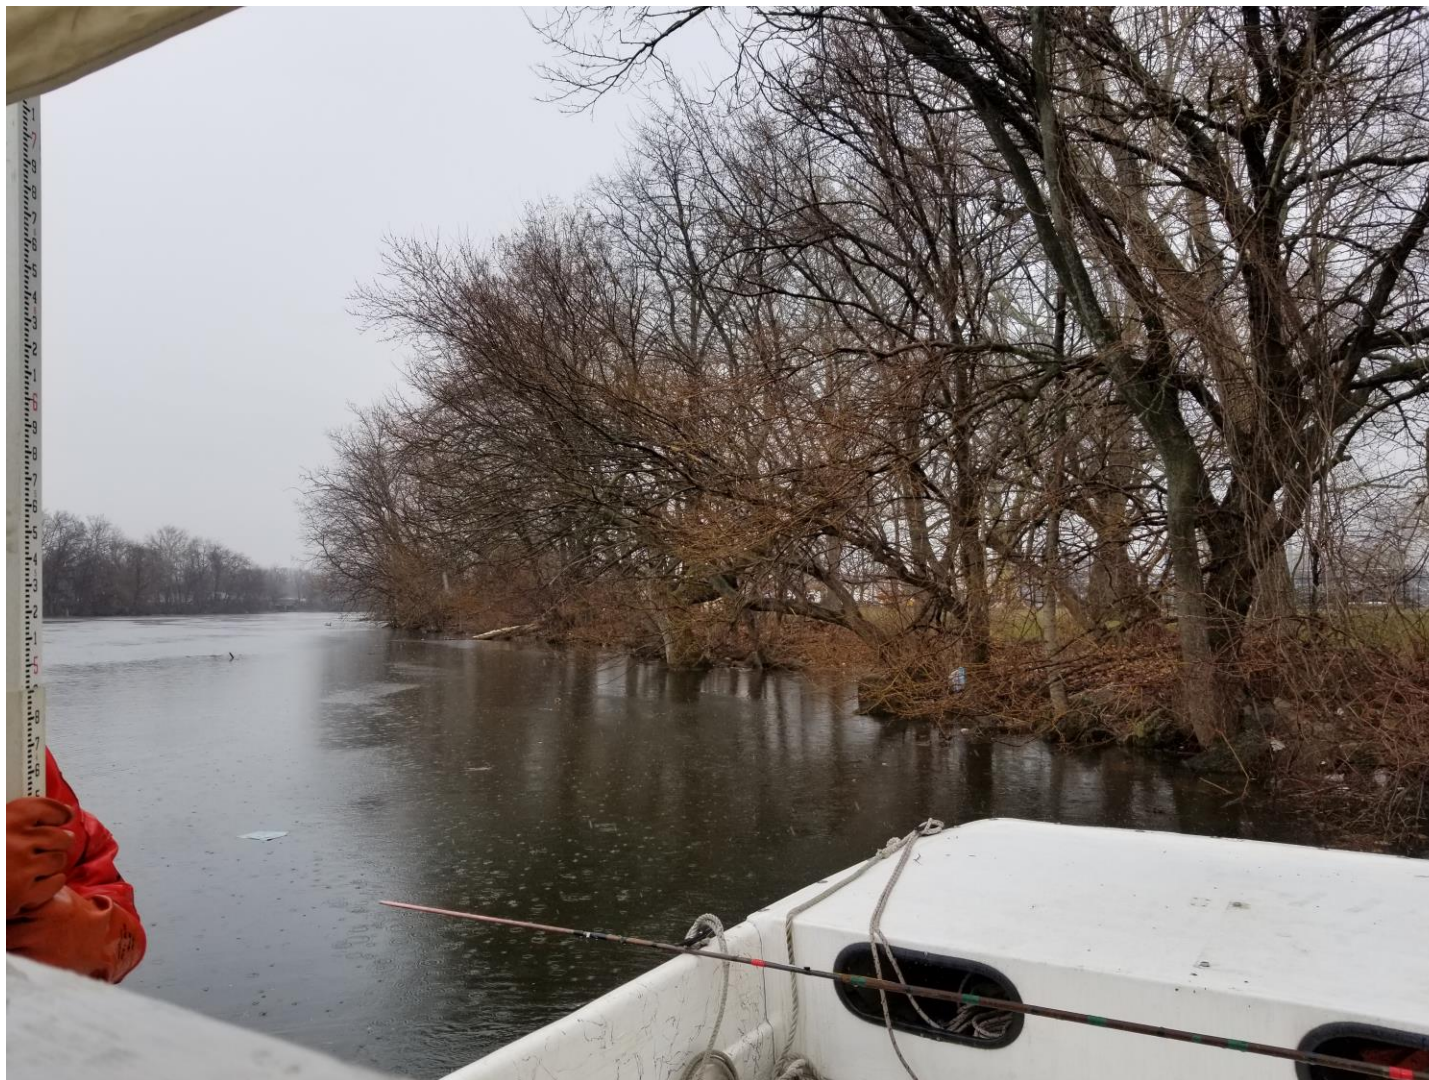
Shoreline at location F-1 looking North (3/21/2019 10:30)

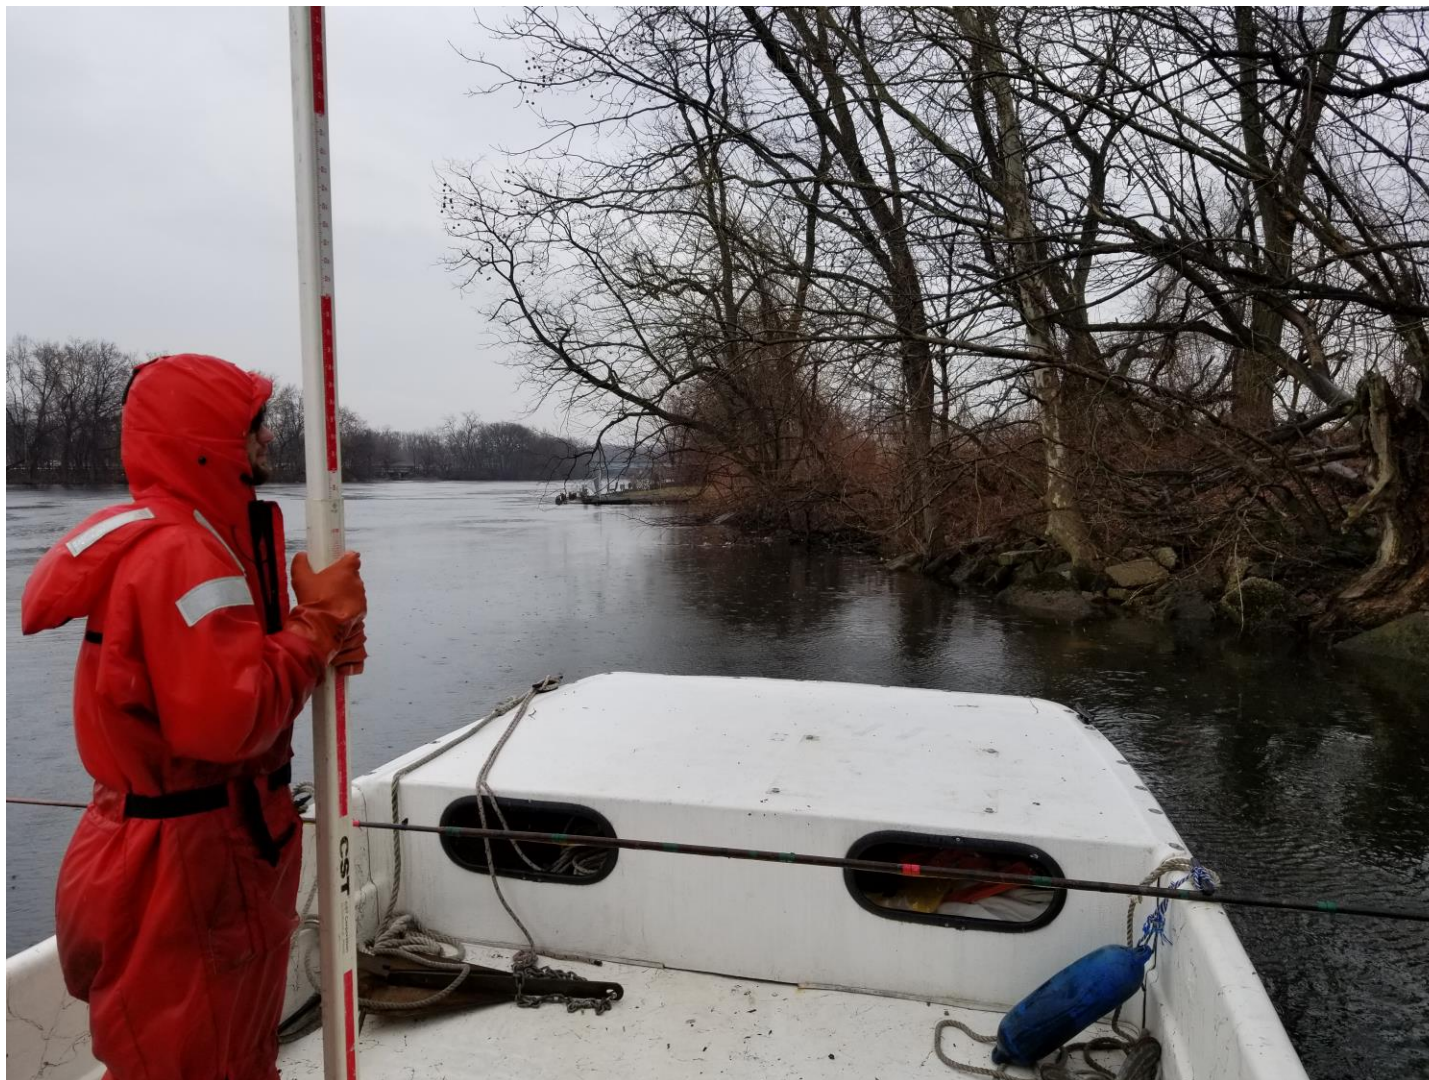
Shoreline at location G-1 looking North (3/21/2019 10:58)

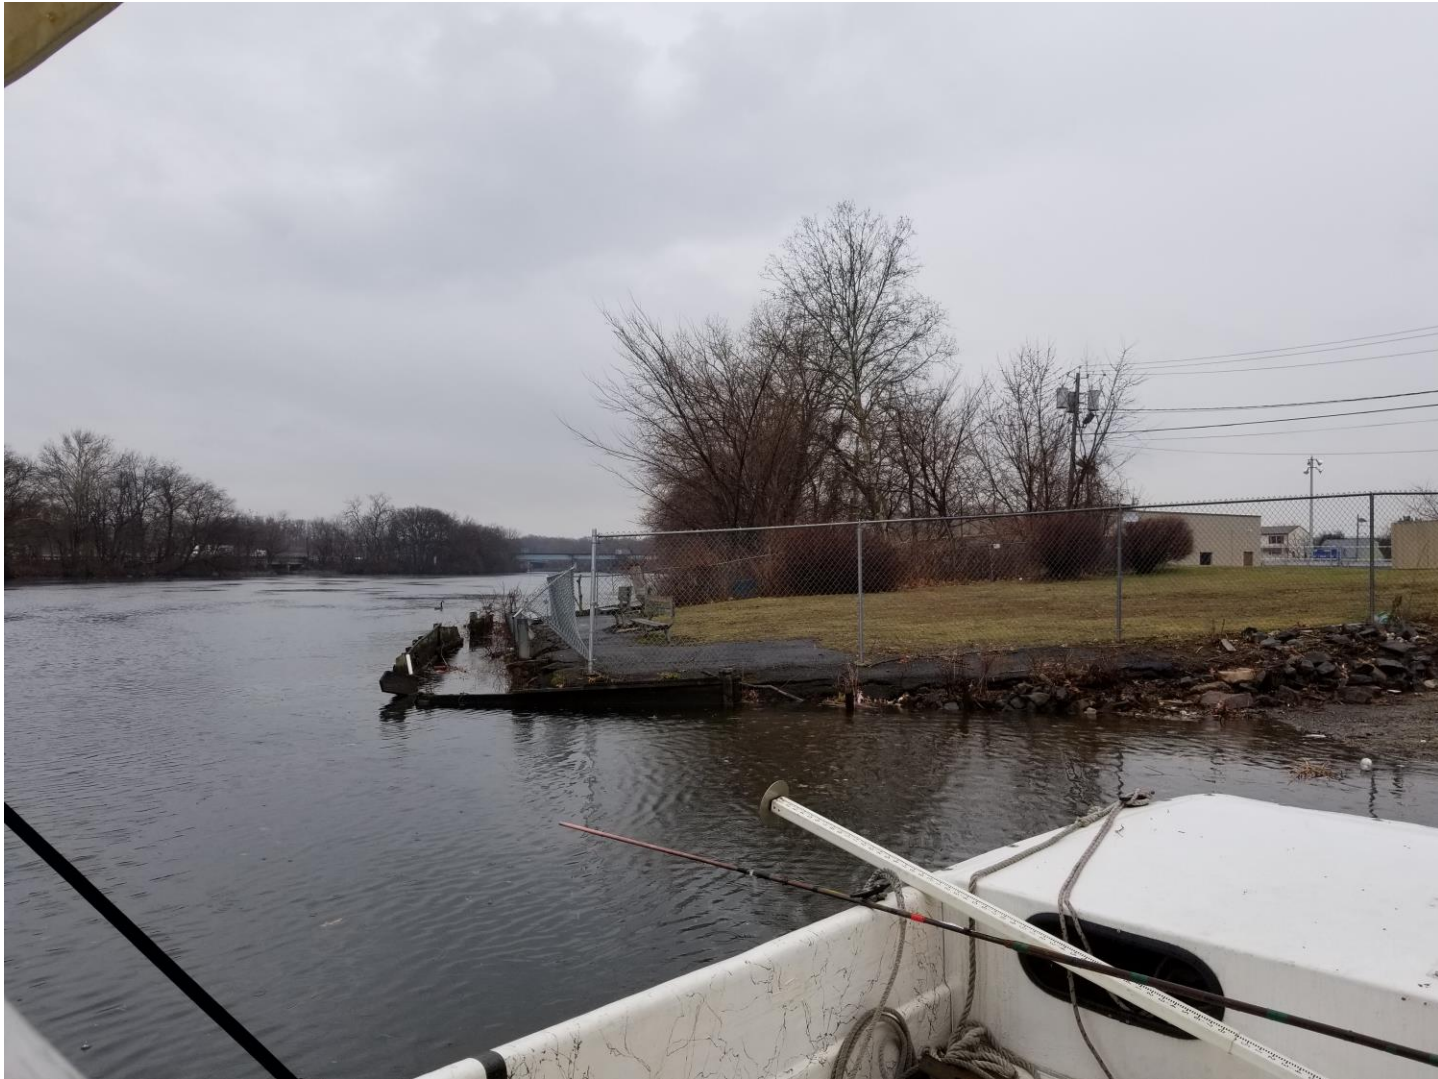
Shoreline and fenced in area located just North of location H-1 (3/21/2019 11:12)

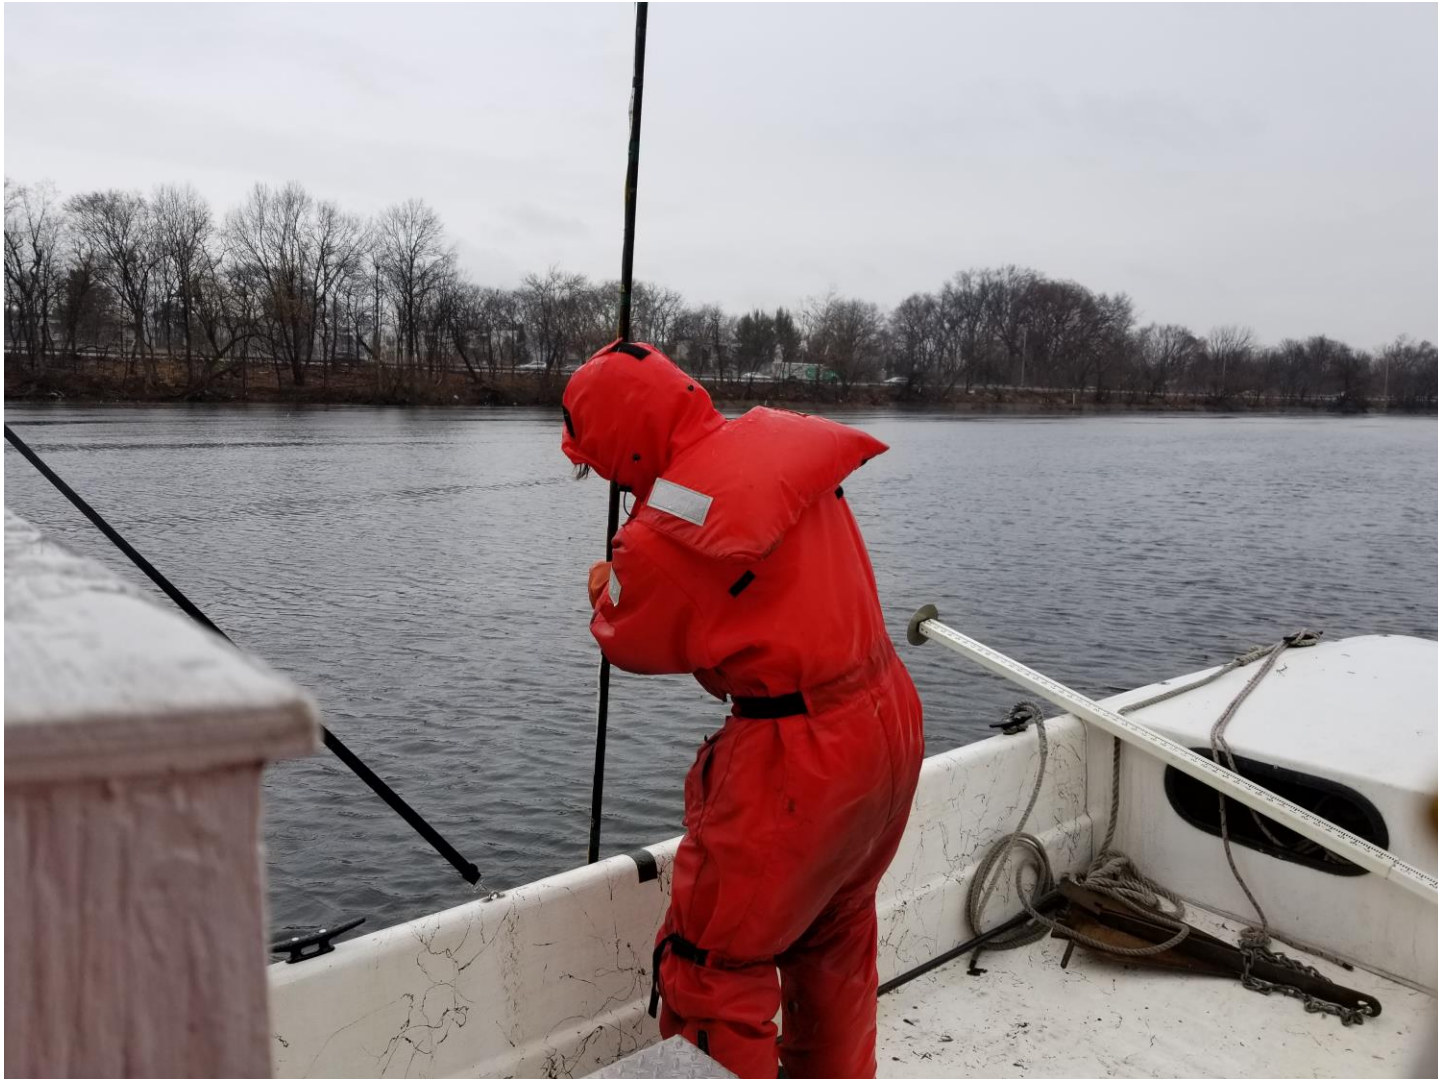
Hugh Lincoln poling for armor at location F-6 (3/21/2019 11:48)
